Tech Help: Chevy Malibu Banjo Bolts

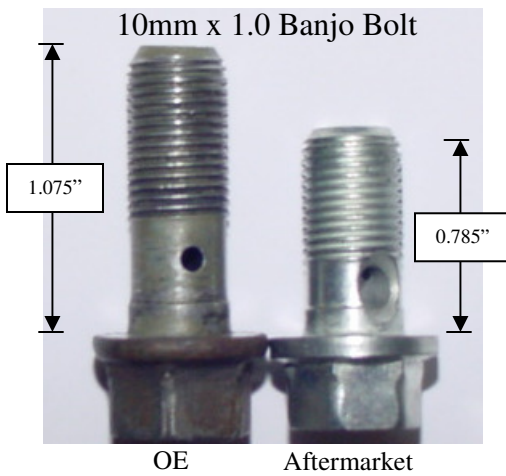
UCX includes banjo bolts on all of its calipers to help insure the integrity of the inlet threads. This policy has been successful in 99% of the calipers that we remanufacture. However, a situation has arisen on the Chevy Malibu caliper. The situation is caused by a difference in the OE and Aftermarket Banjo Bolts. Shown below is a photo of the Banjo Bolts for the Malibu caliper.

The Malibu caliper is aluminum and, because aluminum is a soft material, the inlet threads are easily damaged. The OE recognized this potential problem and designed the Banjo Bolt to have a much longer thread area. By providing more threads, there is a greater chance that the bolt will attach to the caliper even if a few threads in the casting are damaged. The problem with the aftermarket bolt is that if the first few threads in the casting are damaged there are not enough threads on the bolt to secure it to the casting (note that the first few threads are the most susceptible to damage). If this situation occurs, there is not a problem with the caliper. Simply clean the OE Banjo Bolt and re-use it.

UCX is working on sourcing the longer OE banjo bolt to solve this situation long term. In the meantime, this information is provided to help you with understand the situation if it arises in your shop.
