BRAKE JOB: GM Acadia / Buick / Outlook / Enclave

The Lambda Platform is shared with the Chevrolet Traverse, Saturn Outlook, GMC Acadia and Buick Enclave. It is largely derived from the GM Epsilon platform, the same platform that makes the Chevrolet Malibu and Pontiac G6. These vehicles can be front- or all-wheel drive. All models have the same rear disc brake setup with the parking brake in the hat of the rotor. All Lambda platform vehicles incorporate Tire Pressure Monitoring (TPMS) ABS and Stabilitrak electronic stability control.

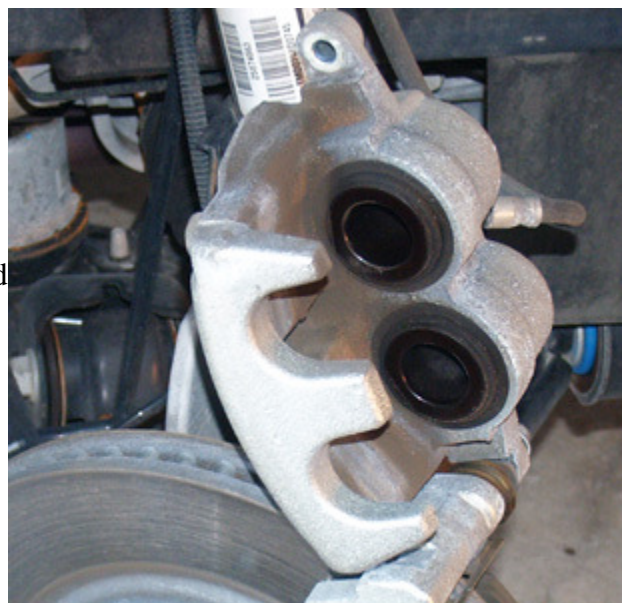
The pads are retained in the bracket

with anti-rattle clips. To release the pad from the clip, there are tabs at the ends of pad that are depressed to release the pad. The pads have noise dampening material attached to the back of the pads.

Before replacing the pads, inspect the master cylinder to ensure that it has not been topped off before retracting the pistons into the caliper bores. The front brakes are a floating dual-piston caliper type, the pistons are phenolic. The caliper bridge bolts have a guide pin and bolt that attach the caliper to the bracket. Removing the bottom bolt allows the caliper to be pivoted out of the bracket. Using a special piston retractor designed to push evenly on the dual pistons is highly recommended.

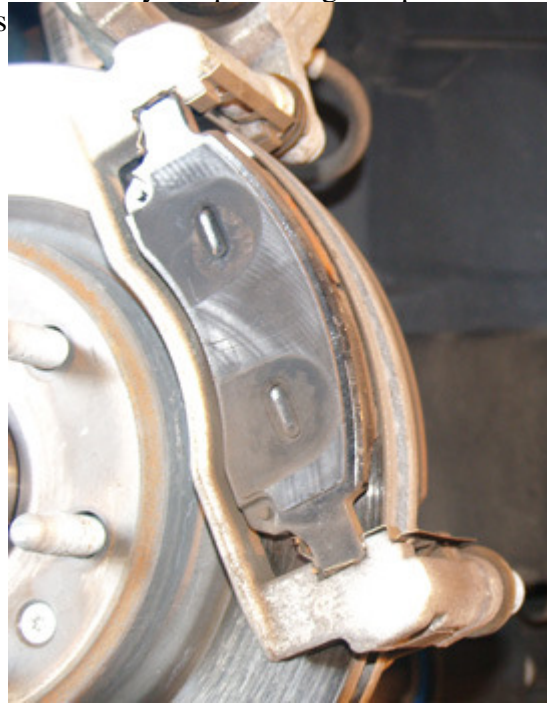
The caliper bracket bolts on this vehicle use high strength thread locker to hold it in place (it is the "red stuff"). Make sure to clean the old thread locker material off the threads with denatured alcohol before putting new thread locker on. The bolts should be tightened to a whopping 129 ft/lbs!

Inspect the dust boots for damage and replace if necessary. Inspect the guide pins and replace and lubricate if necessary. The boot is to be seated in the grooves of the caliper bracket and guide pin.

Install new anti-rattle clips and pads, rotate the caliper and align the flats on the guide pin to the mounting ear of the caliper. Torque the guide pin bolts to 64 Nm (30 ft/lbs).

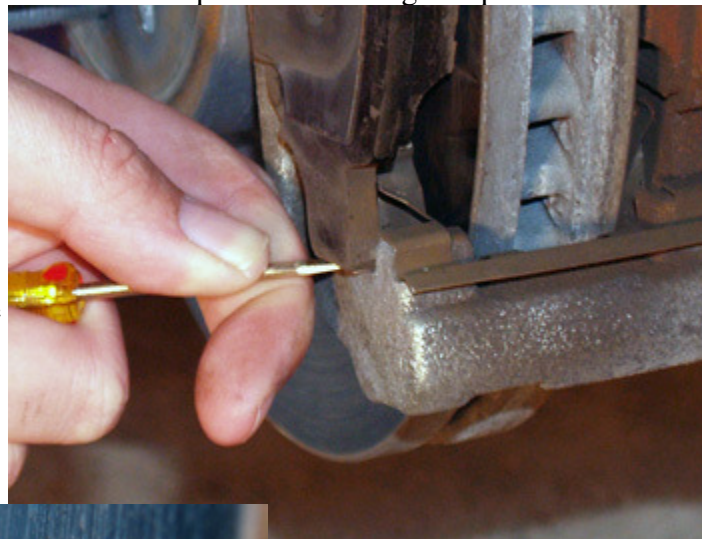
Like in the front, the rear caliper brackets use thread locker. Make sure to clean threads. Then torque the bolts to 148 ft/lbs.

Inspect the dust boots for damage and replace the caliper if necessary. Inspect the guide pins and replace and lubricate if necessary.

The boot is to be seated in the grooves of the caliper bracket and guide pin. Install new anti-rattle clips and pads rotate the caliper and align the flats on the guide pin to the mounting ear of the caliper. Torque the guide pin bolts to 64 Nm (30 ft/lbs).

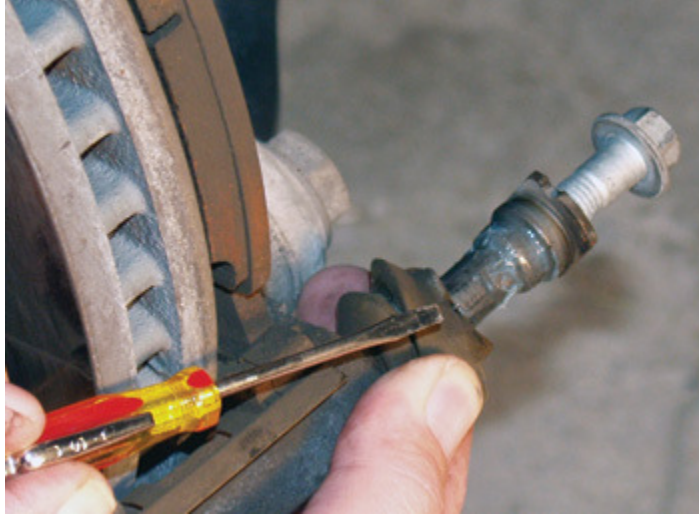
Rotor Lateral Runout Inspection Procedure

The hub and rotor are matched with the rotor indexed to the hub and secured with a Torx setscrew. Three lugs should be used to ensure the rotor is secured to the hub. Attach the dial indicator to the steering knuckle and position the indicator at 90° to the rotor surface approximately 12.7 mm (0.50") from the rotor. Replace any rotor that is worn or machined below this specification.

If the rotor is within runout specification, new pads and anti-rattle clips can be installed. If the rotor is out of specification for lateral runout, a shim between the hub and rotor can correct the runout.

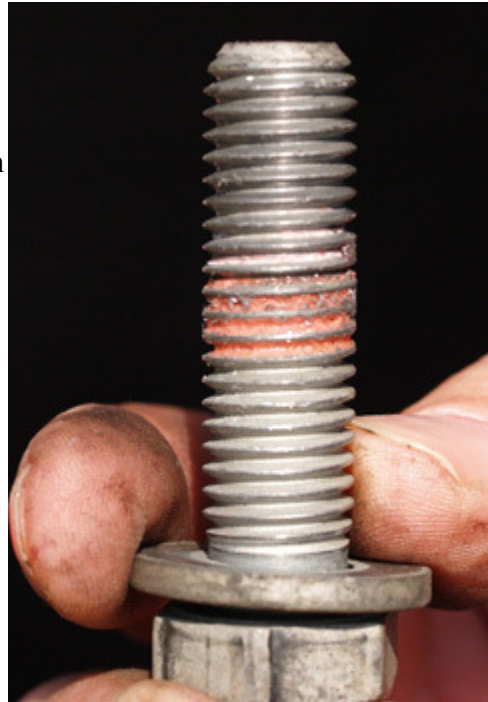
Remove the caliper bracket. It is secured to the knuckle with 19 mm bolts with thread lock adhesive. When replacing the bracket, clean the bolt and apply thread lock adhesive to the center section of the threads. Torque the front caliper bracket mounting bolts to 175 Nm (129 ft/lbs). The torque the rear to caliper bracket mounting bolts to 200 Nm (148 ft/lbs). Remove the Torx retaining screw and rotor. The hub is checked at the outer machined surface with the indicator at 90° to the rotor's surface.

Mark the hub for run out and the stud closest to the high spot. The machined surfaces of the hub and rotor should be cleaned before the shim is installed with the V-notch aligned

with “high spot” on the vehicle hub. Reinstall the rotor and torque the retaining screw to 12 Nm (106 in/lbs).

GM has approved the shims from Brake Align for the correction of the runout for rotors machined on both on- and off-vehicle lathes. Mark the high spot on the rotor and the stud closest to the high spot. To check the bearing hub, remove the caliper bracket and rotor.
