BRAKE & FRONT END

Brake Job: 2002-2008 Ford Explorer

Andrew Markel

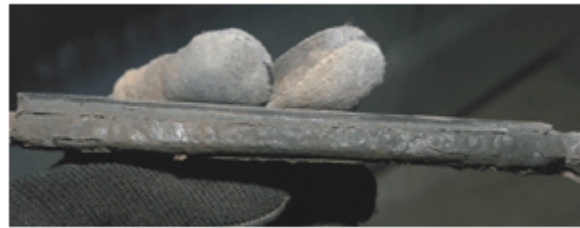
If the vehicle has too much thickness variation or tapered wear, it is a sign that there could be problems with the brake hardware or the caliper pistons. Our Explorer Sport Trac had tapered wear on the outer brake pad because the rubber bellows that cover the lower anchor pin were unseated and had seized.

Look at the brake pads for any sign of abuse. Look for signs of rust jacking between the backing plate and friction material. This causes the edge lift and material separation. The customer may also notice noise and vibration.

Make sure to measure the thickness of the pads. The minimum thickness is 3mm, this is a lot of material to the naked eye. Ford specifies that the pads can not vary in thickness from inner-to-outer pad by more than 2mm. Also, Ford specifies that there can only be 3mm of tapered wear.

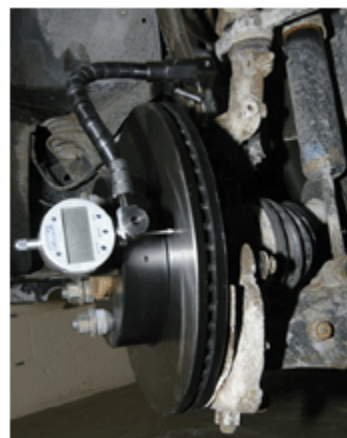
Technicians are often confused by Ford's rotor specs. In the past, Ford printed or stamped the minimum and "discard" thickness of the rotors. Now they call it "thickness to machine." Confused? The minimum thickness is the thickness that the rotors should not drop below before or after machining the rotor. The discard or "thickness to machine" specification is a number (usually 0.7-.9mm added to the minimum thickness) that should be used to determine if a rotor can be machined.

The rotors should have no more the 0.001" of runout and 0.0004" of thickness variation.

- Front brake rotor minimum thickness: 24.5mm (0.9646")
- Rear brake rotor minimum thickness: 11.0mm (0.4331")
- Front minimum thickness to machine (Discard): 25.1mm (0.98")
- Rear minimum thickness to machine (Discard): 11.6mm (.45")
